A Case Study on River restoration Børselva, 1997- 2007.

*Karl Jan Aanes, Norwegian Institute for Water Research
COST 869. Keszthely May 6 – 8 - 2009.*

Adapting a regulated river to a new flow regime.

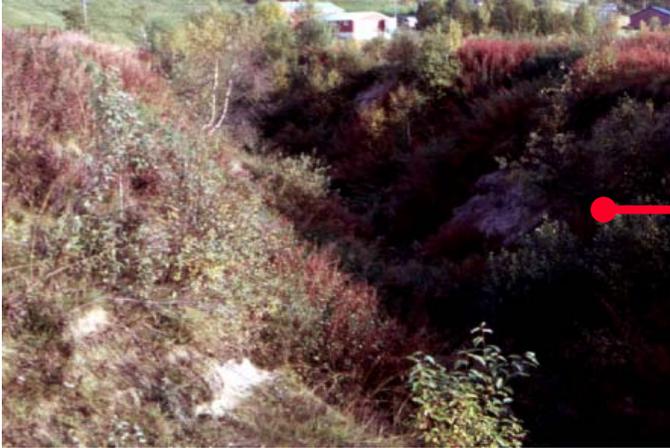
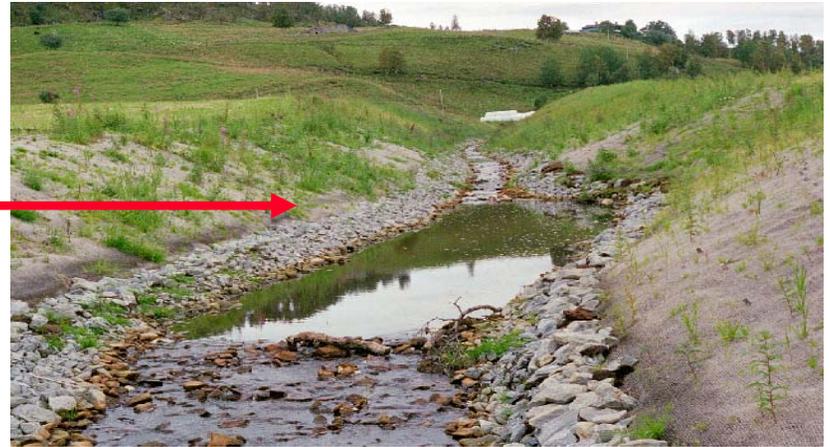
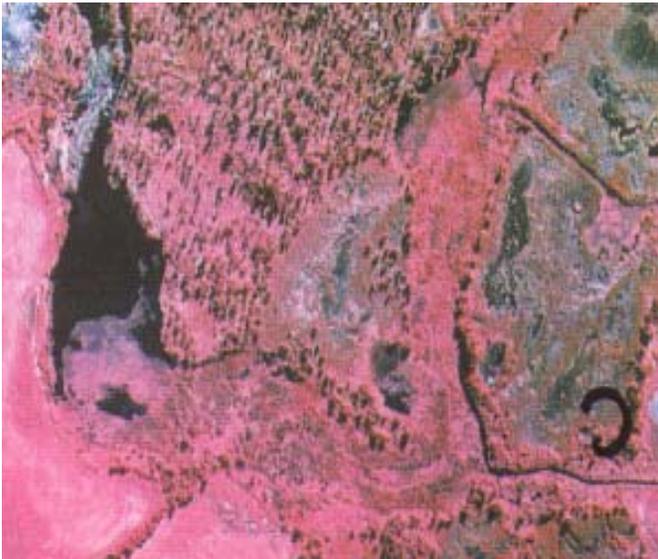
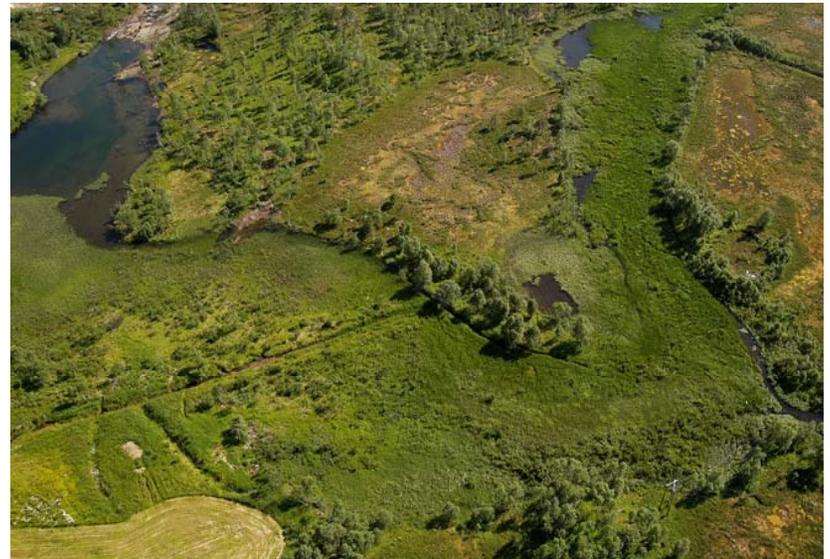
Siltation

1. **E**rosion in a tributary created siltation problem
2. **T**he high input of nutrients and organic material from agricultural activities along the river created eutrophication problems
3. **T**he reduced water flow

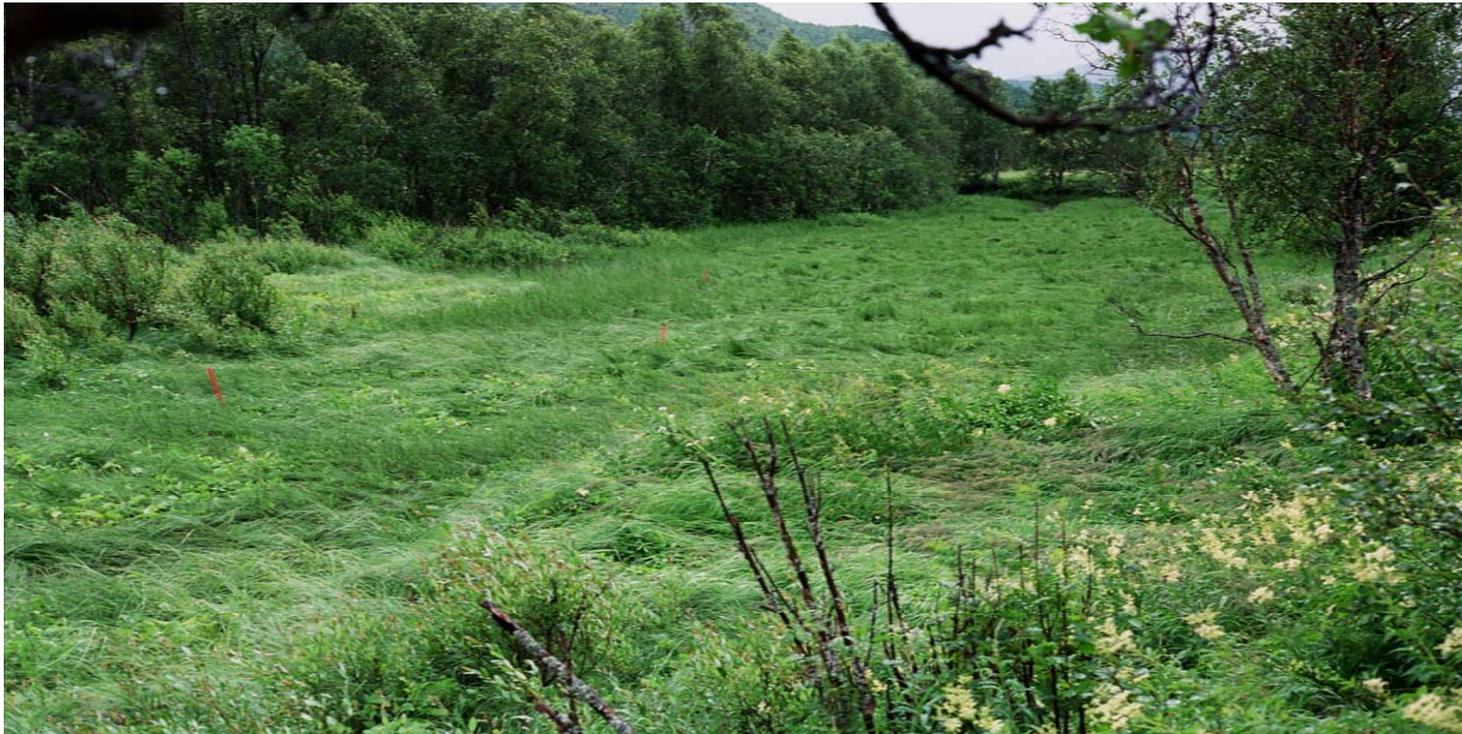
Eutrophication

The river was drastically changed and nearly **70%** of the river bed was covered with water plants.

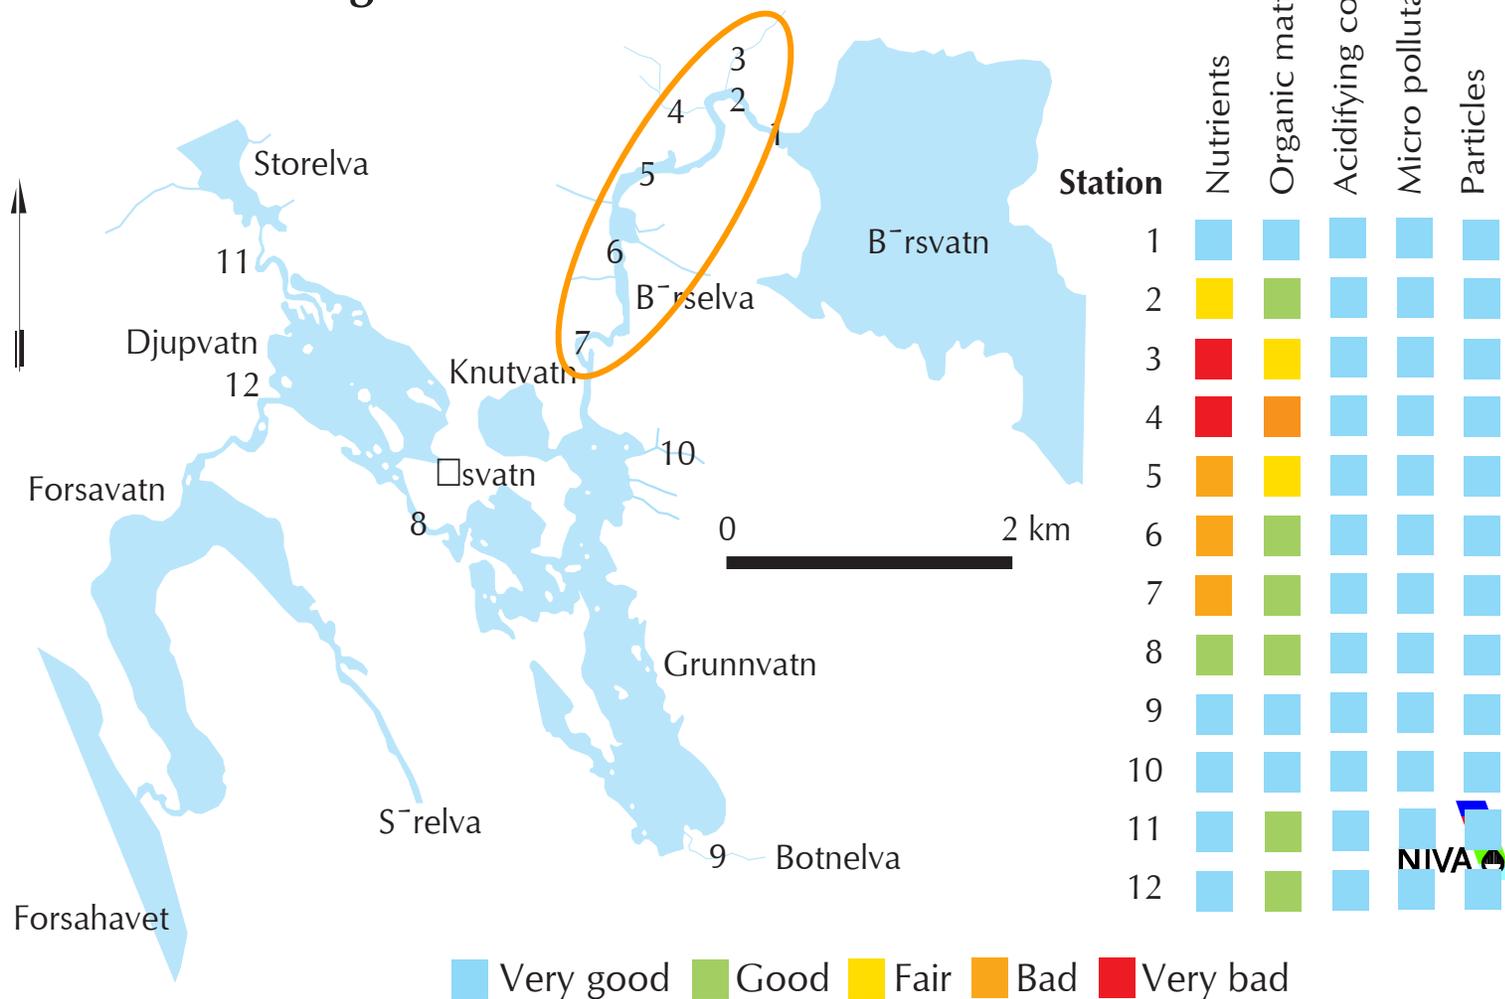
Water quality

Results from a monitoring programme describes the water quality in the River
 - the system is heavily overloaded with nutrients and organic matter

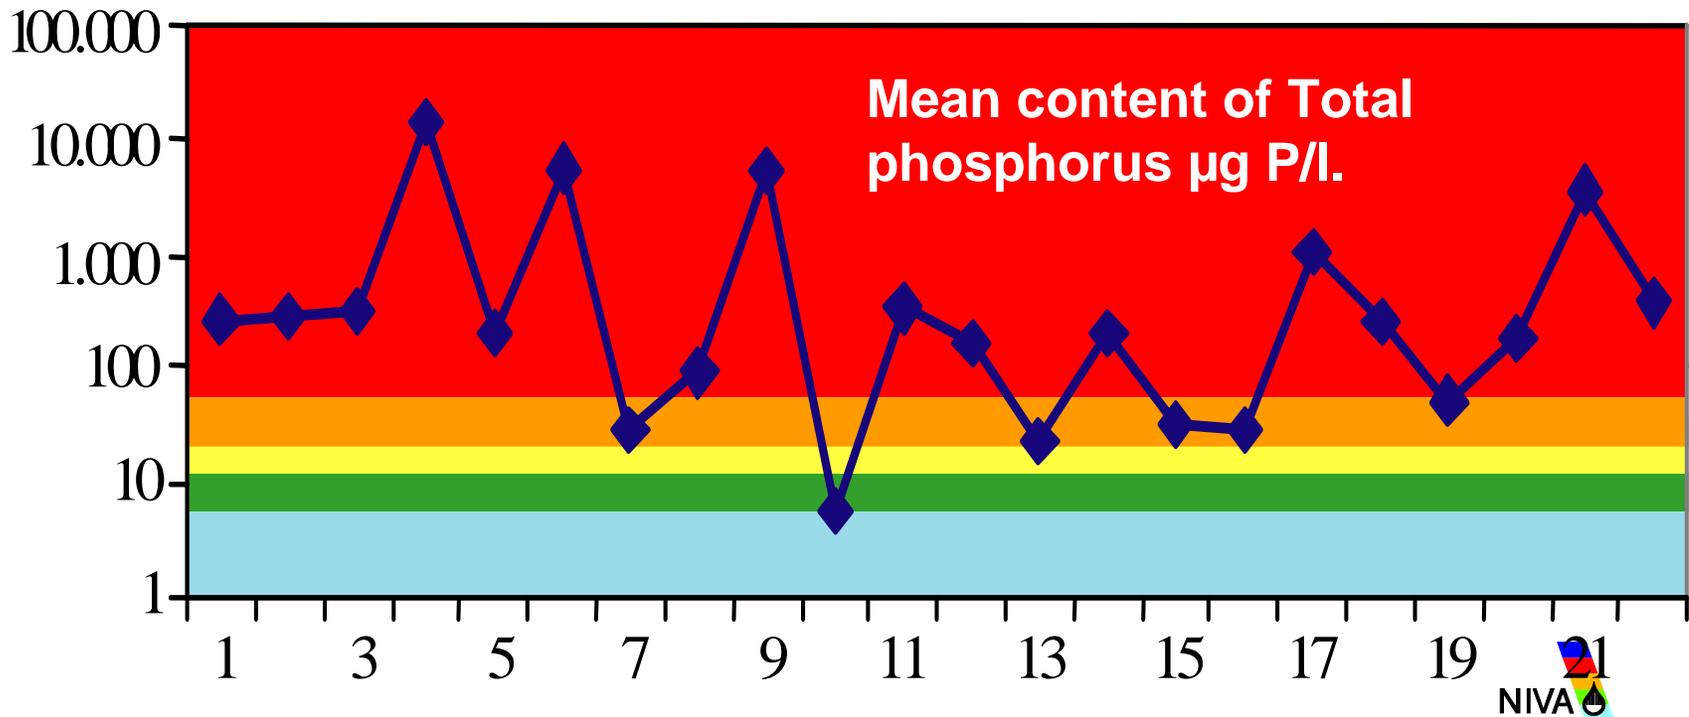
Pollution

Results from a monitoring programme of all tributaries indicated that **80 %** of the nutrients and organic material were due to the farming activity.

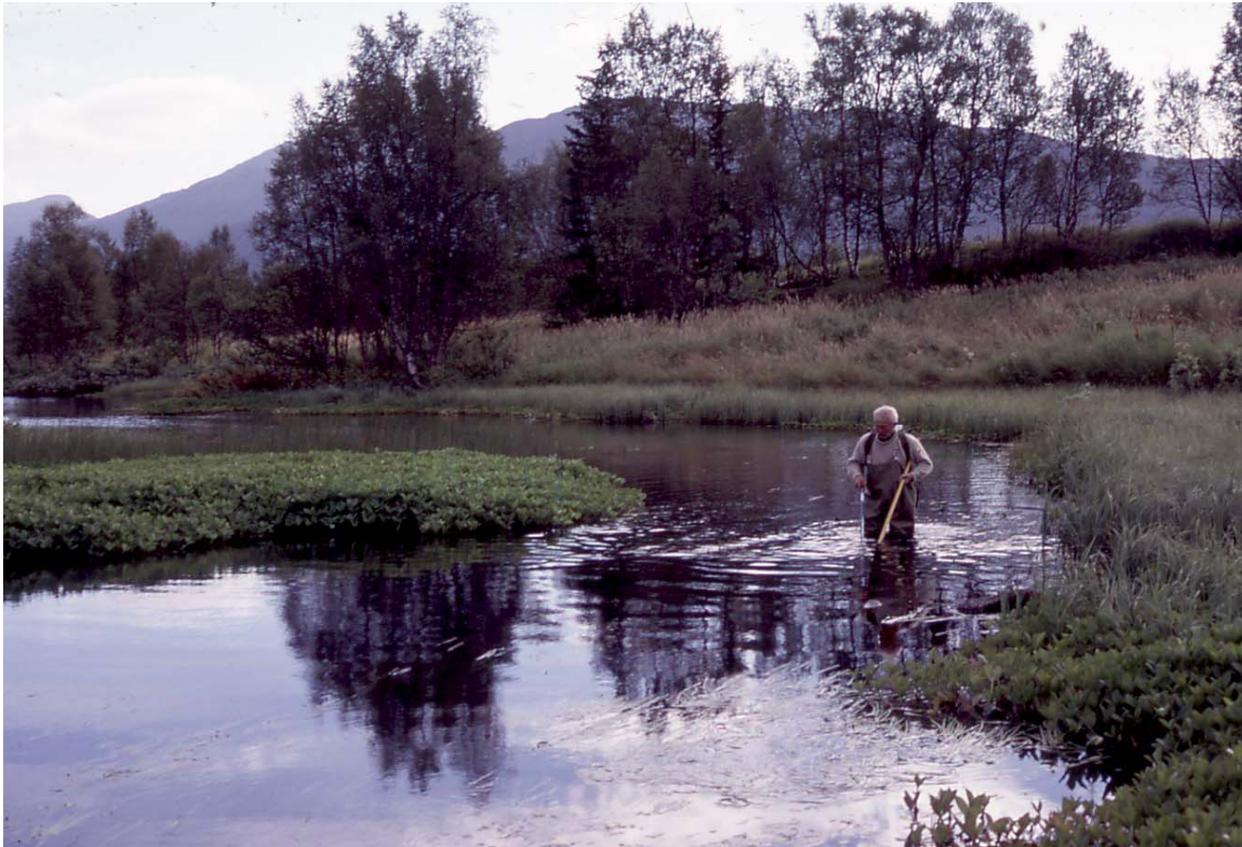
Fish

- Børselva was earlier the main spawning and recruiting area for the lakes downstream and had a valuable population of arctic char and trout.
- Fishing with nets and electro fishing did not catch any fish in 1998 and 1999.

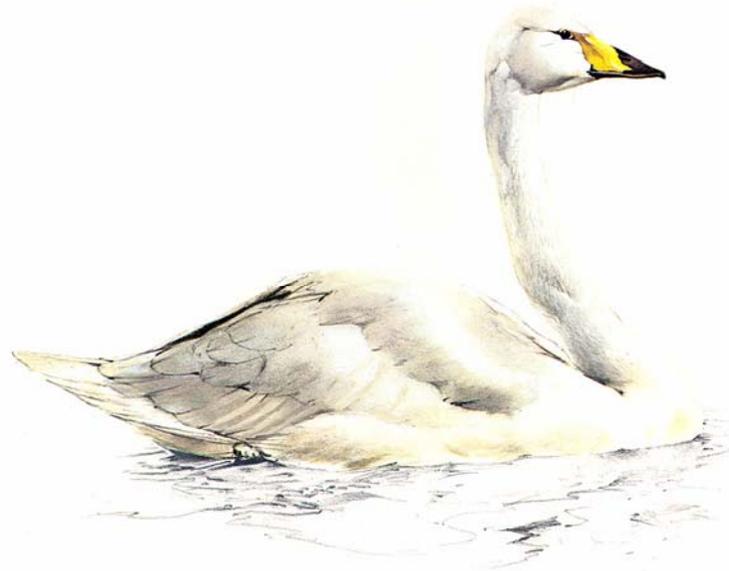
Wildlife reserve

- The water course was early in the project period protected as a nature reserve due to its importance as a feeding and resting area for migratory water birds,.
- A substantial number of different water birds used to nest in the river and lake system some of them were/are red listed species.
- During the most recent years there has been a drastic reduction in number and species present.

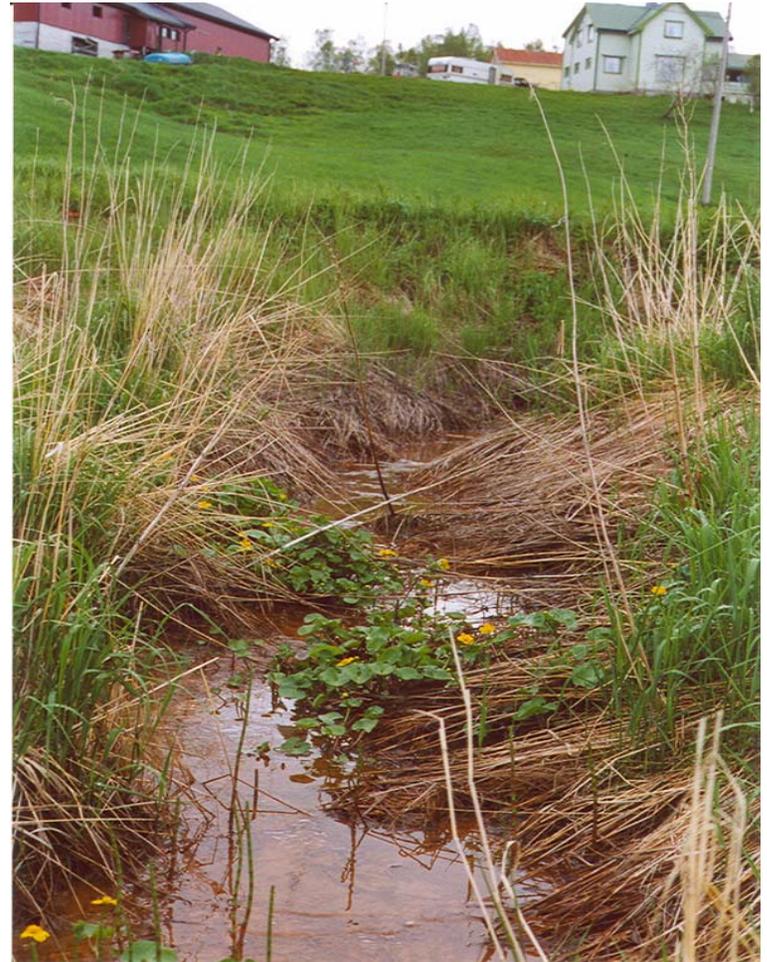
Re-establish a good water quality

- Stop all discharges of nutrients from point sources, and create an awareness among the farmers for the problems seen
- By using capture dams, wetland fields and re-establishing the riparian vegetation along the river (as buffer zones) the run-off from arable land of nutrients will be reduced to an acceptable level.
- The efforts to stop the contamination of the river Børselva was done in parallel with the physical restoration of the river
- Some work have still to be done

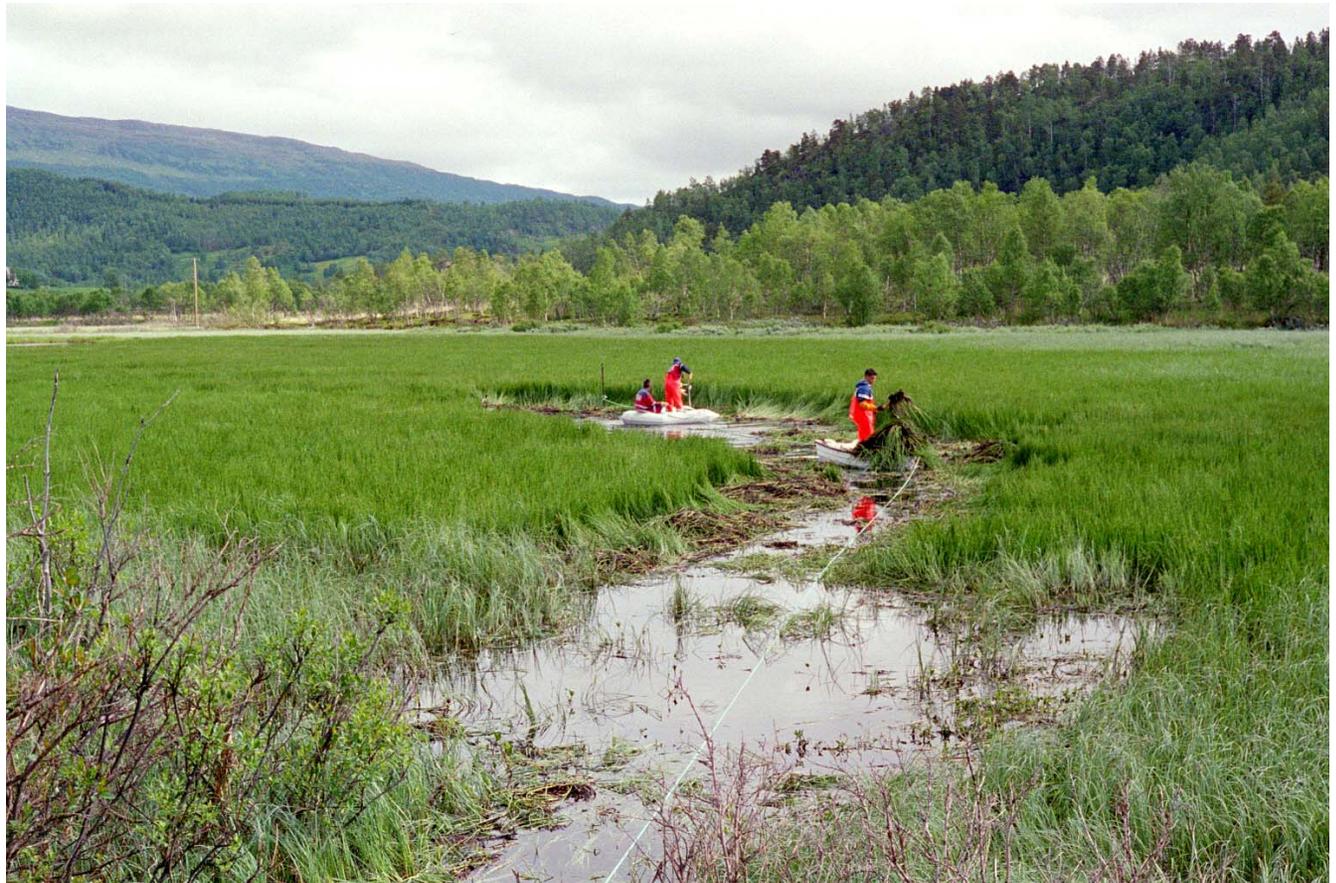
Manual cutting

- Required considerable manpower and resources.
- The cutting had to be repeated regularly
- Disturbed birdlife.

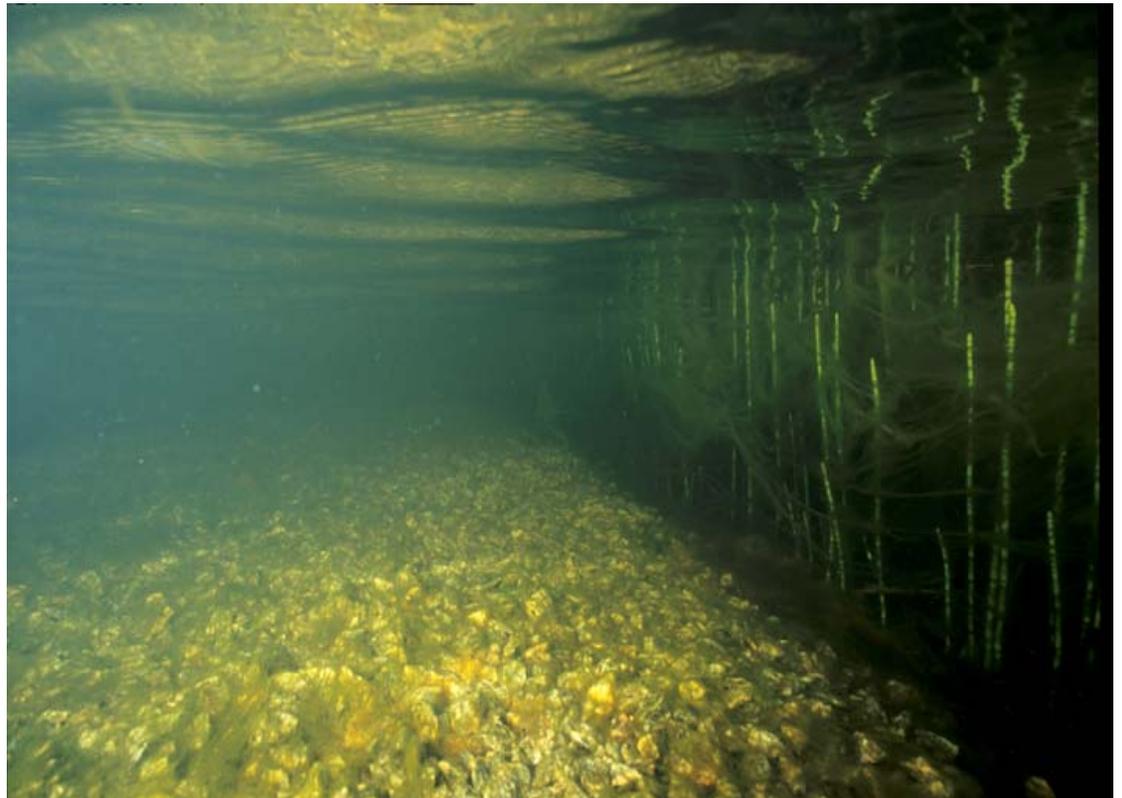
Harvest and Cover

- Another method tested was to cover the opened stretches after the vegetation had been taken away with a geotextile, covered with a 10 cm layer of crushed stones.
- This way to create openings in the vegetation was very promising: We got a new substrate type, but there was still a need for much manpower and the method was by that very expensive.

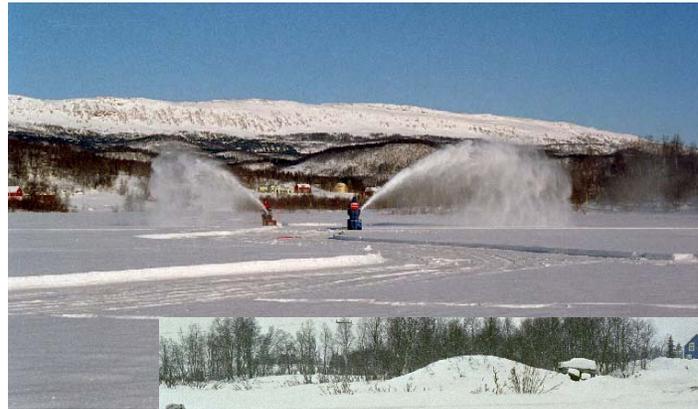
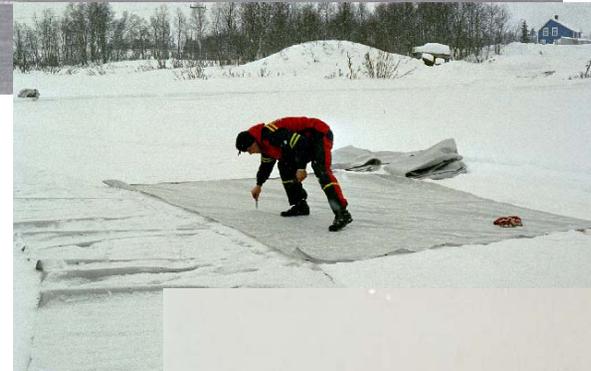
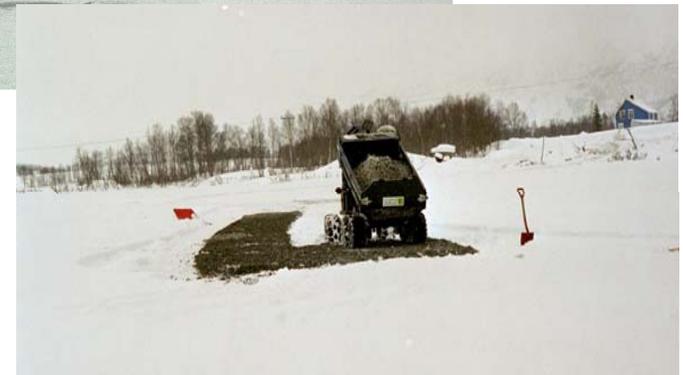
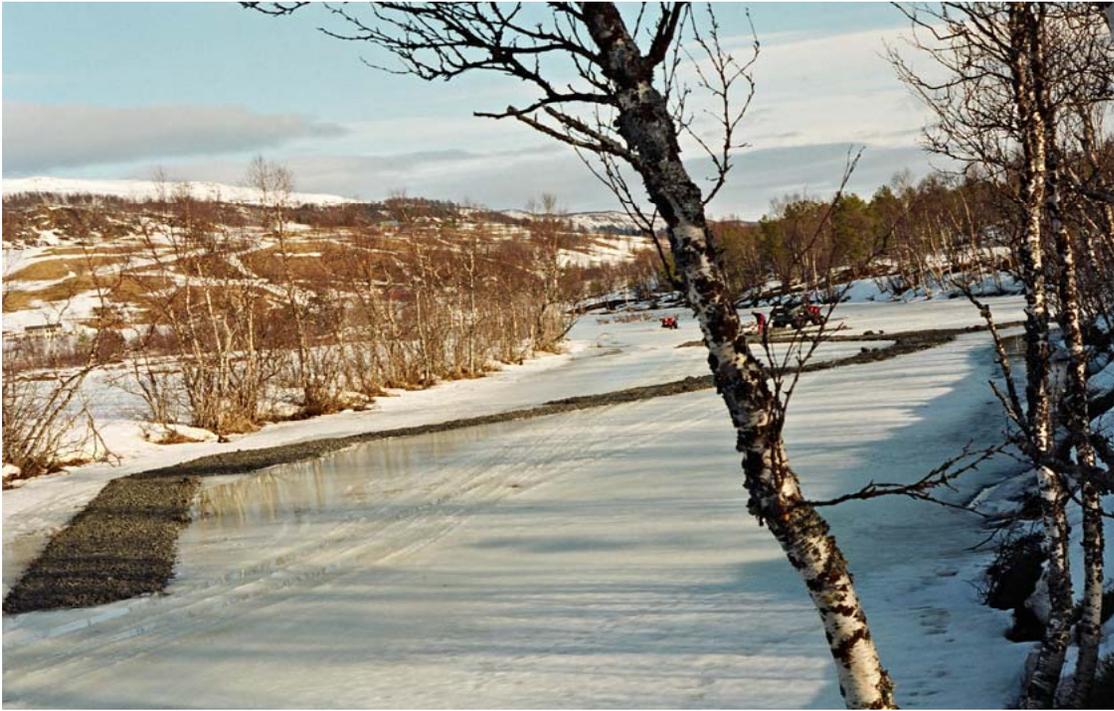
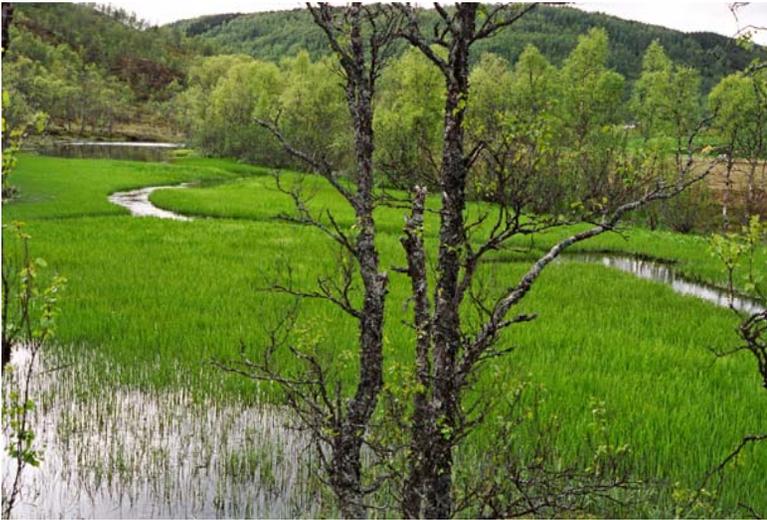
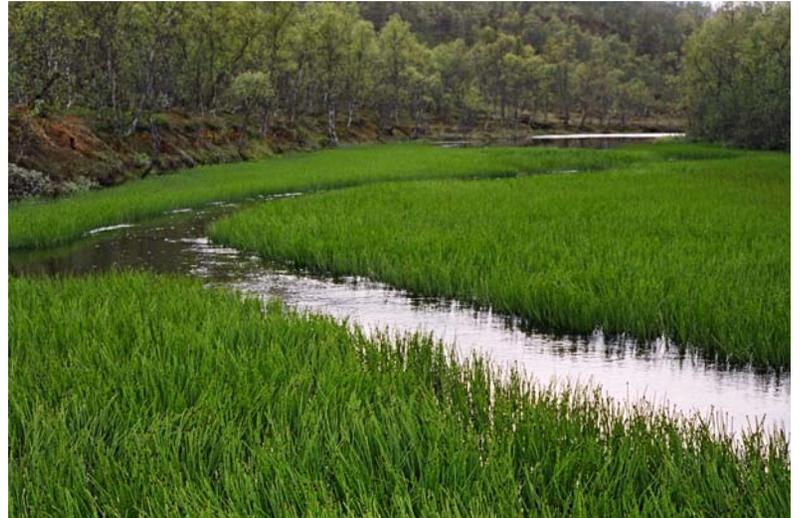
Mechanical methods : III

- Method II was developed further and tested when the river was covered with ice
- The need for manpower was reduced and the method showed to be very cost effective
- When working on an ice covered river this method provided easy possibilities to create a river with curves, changeable width, side arms and new openings in the vegetation.
- By changing the thickness of the stone layer and support this with some bigger stones we created new habitats for fish and benthic fauna.

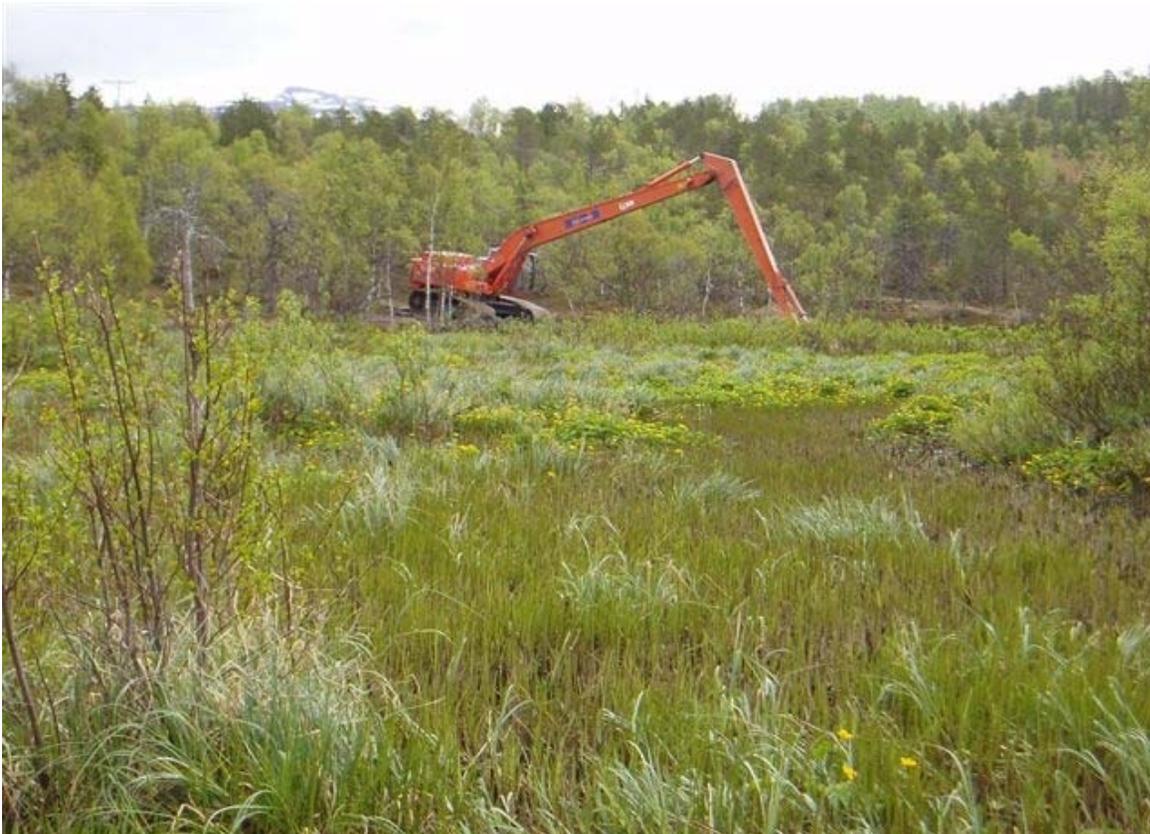
Mechanical methods : IV

- **Excavators**
- When pools and deeper parts of the river was developed an excavators with a long arm was used

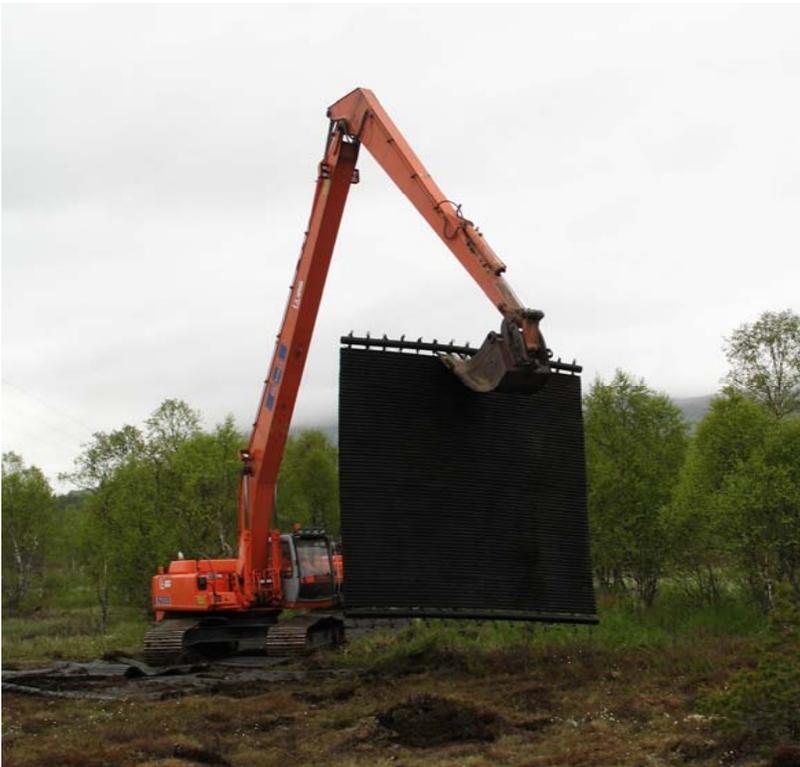
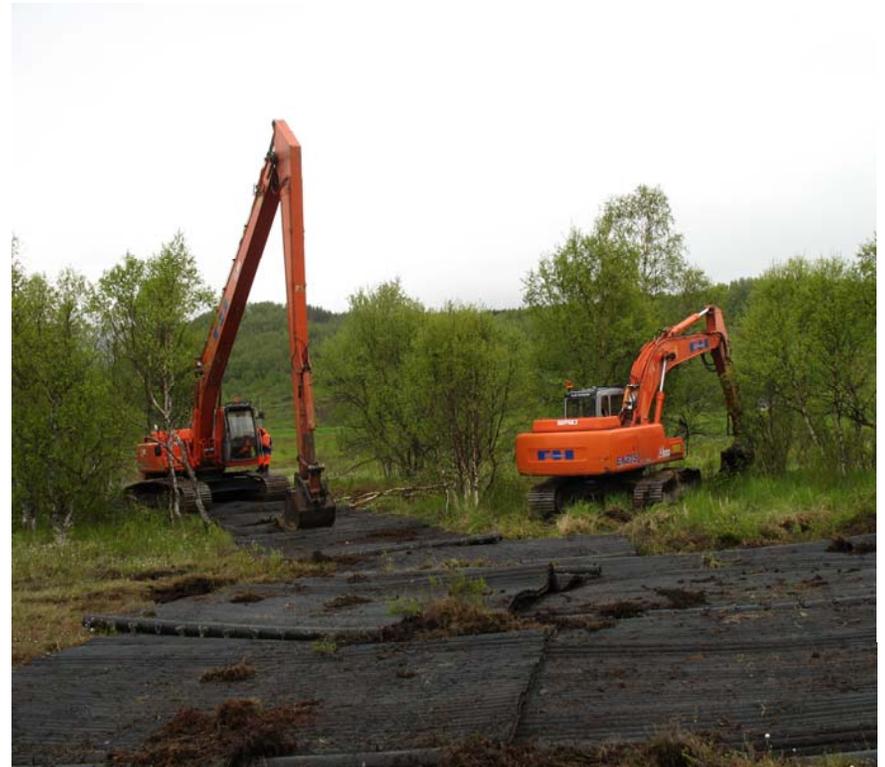
Wetlands protection

- Heavy machinery would have had great difficulties to move along the river – and would have created wounds difficult to repair
- Carpets made for military use for safe and environmentally transport over wetlands was the solution and showed to function very well

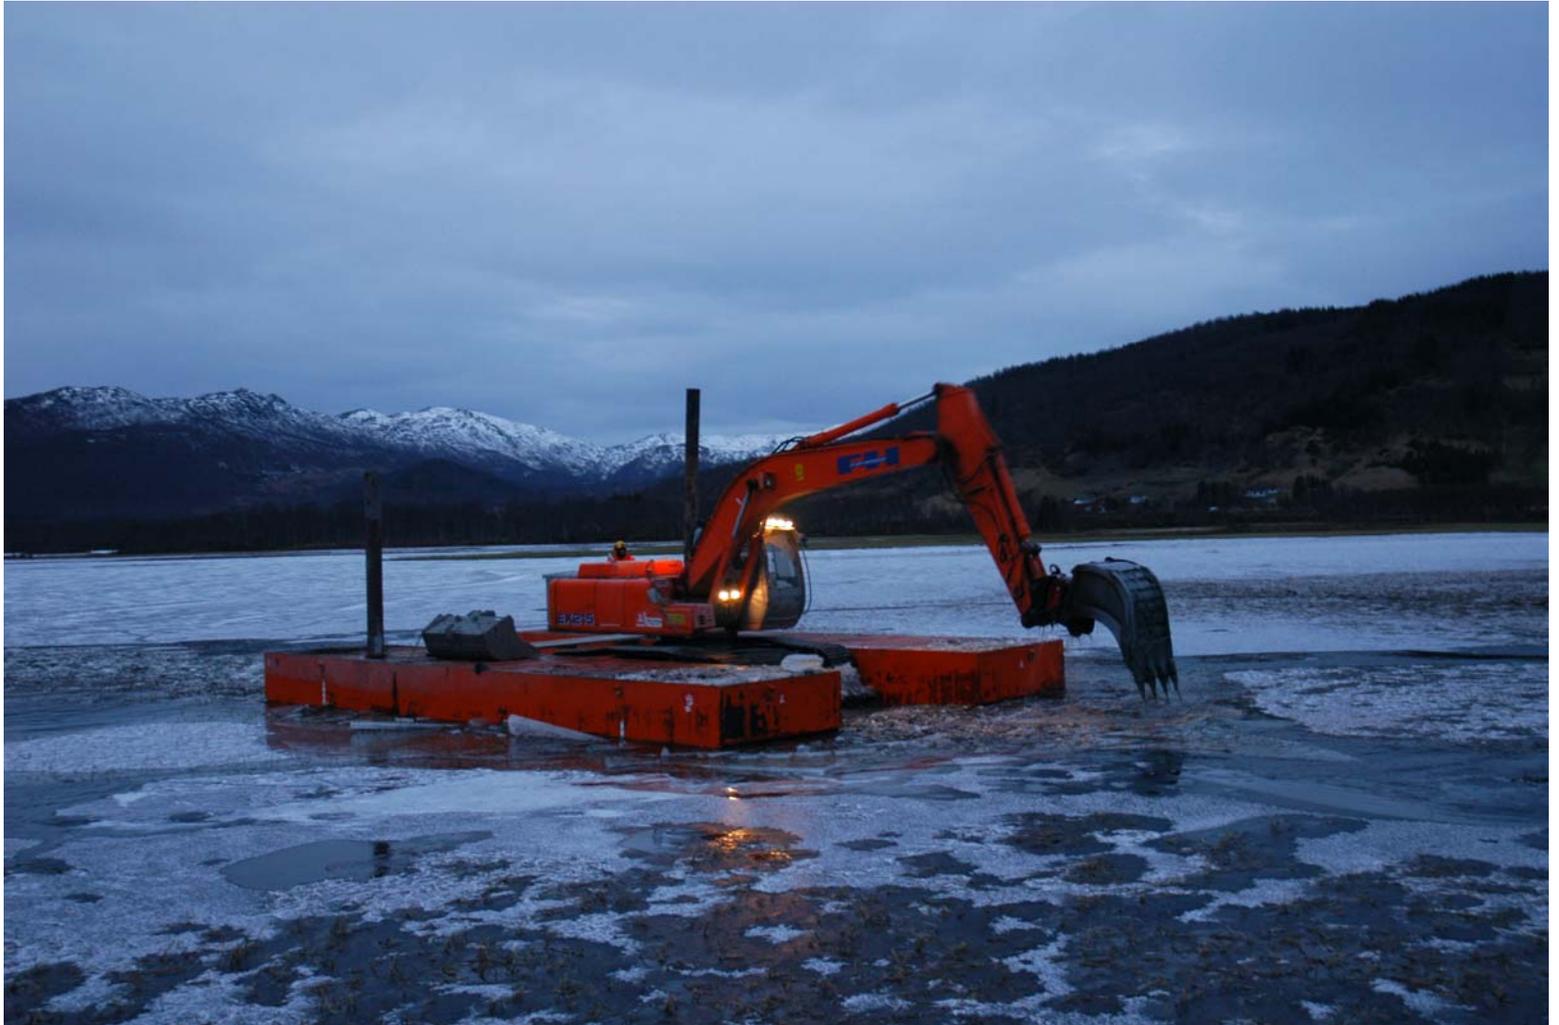
Excavator on a fleet

Work late autumn on the lakes

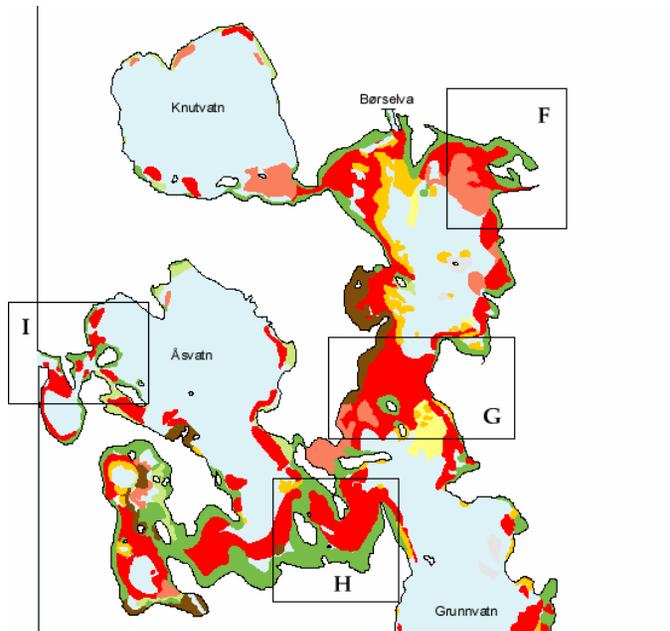
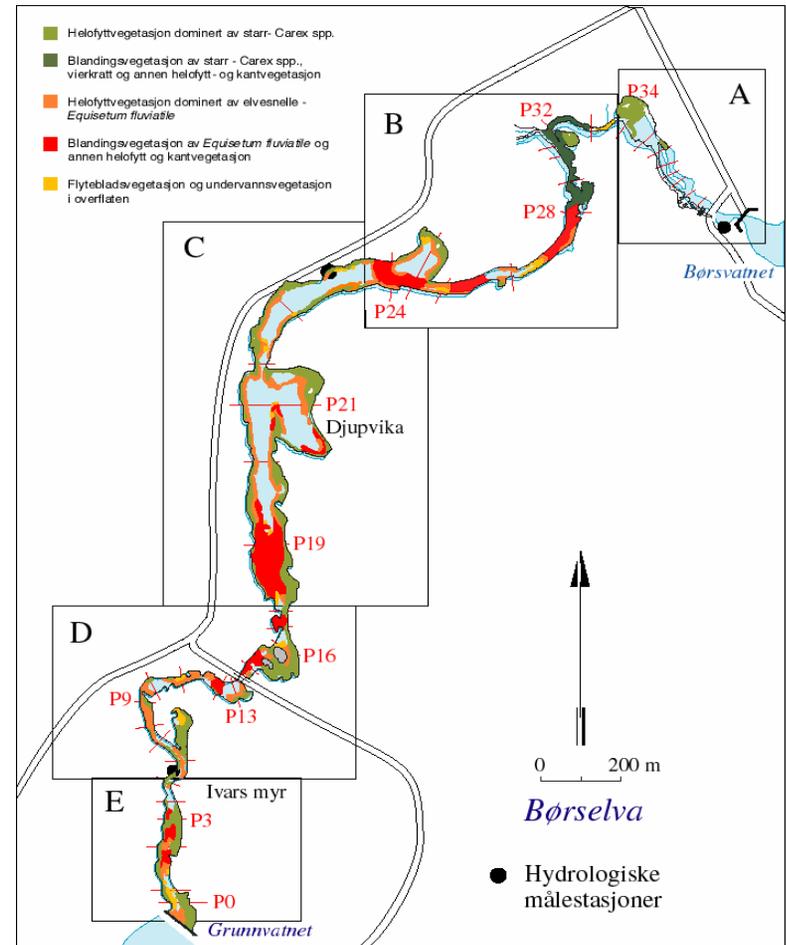
Restauration Plan

The watercourse was divided into separate compartments and a detailed plan for a new river was developed for each section.

Combinations of the textile (NIVA) - method and the use of excavators.

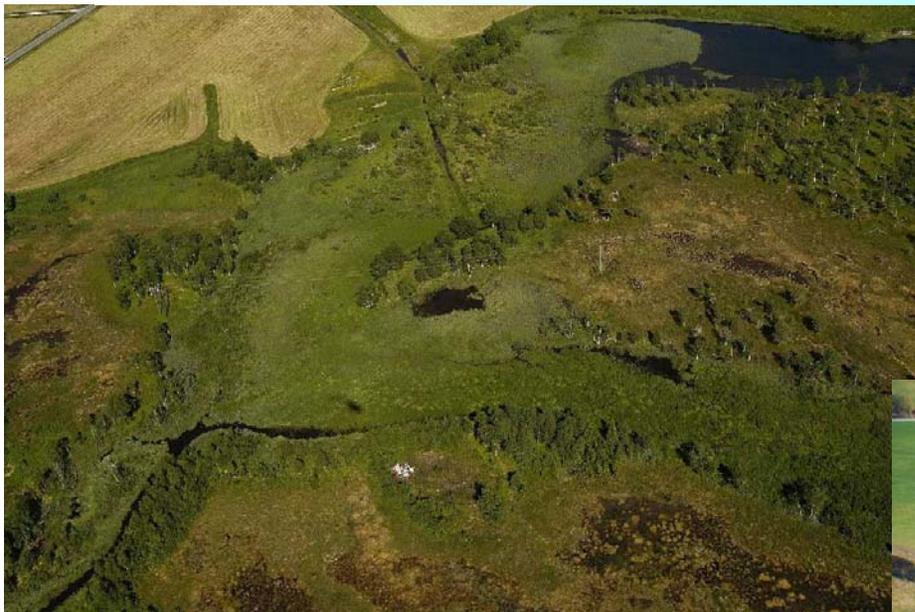
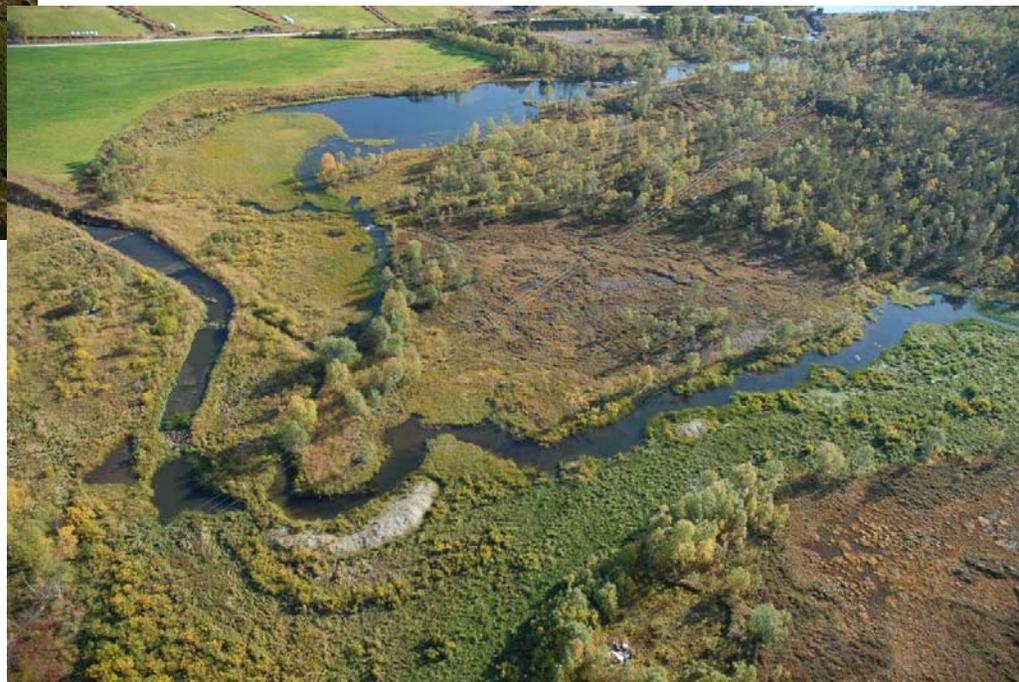
Results: Before and after

2005 → 2008

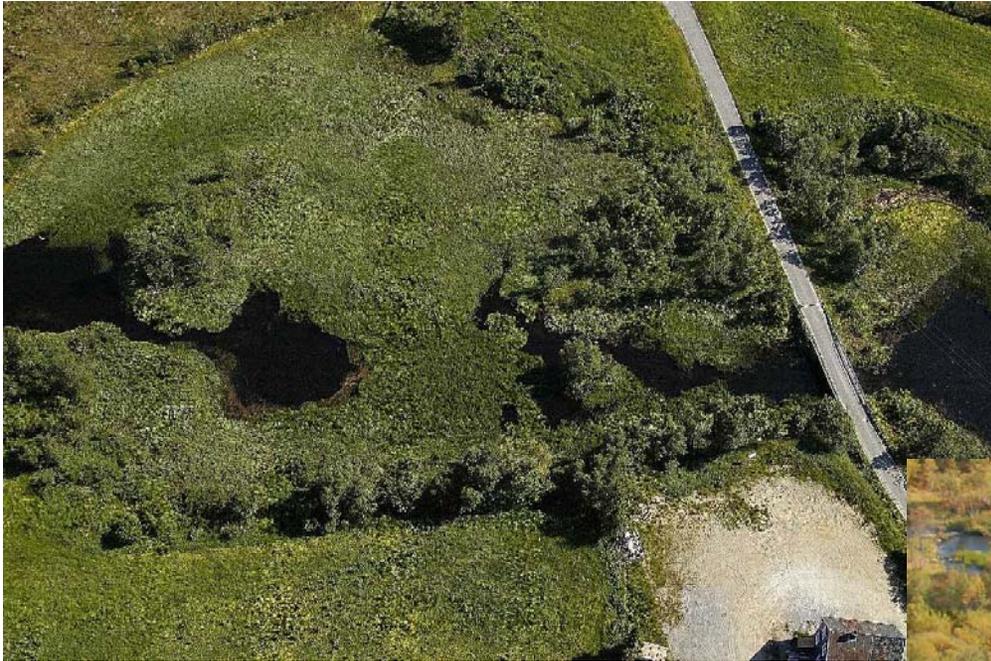
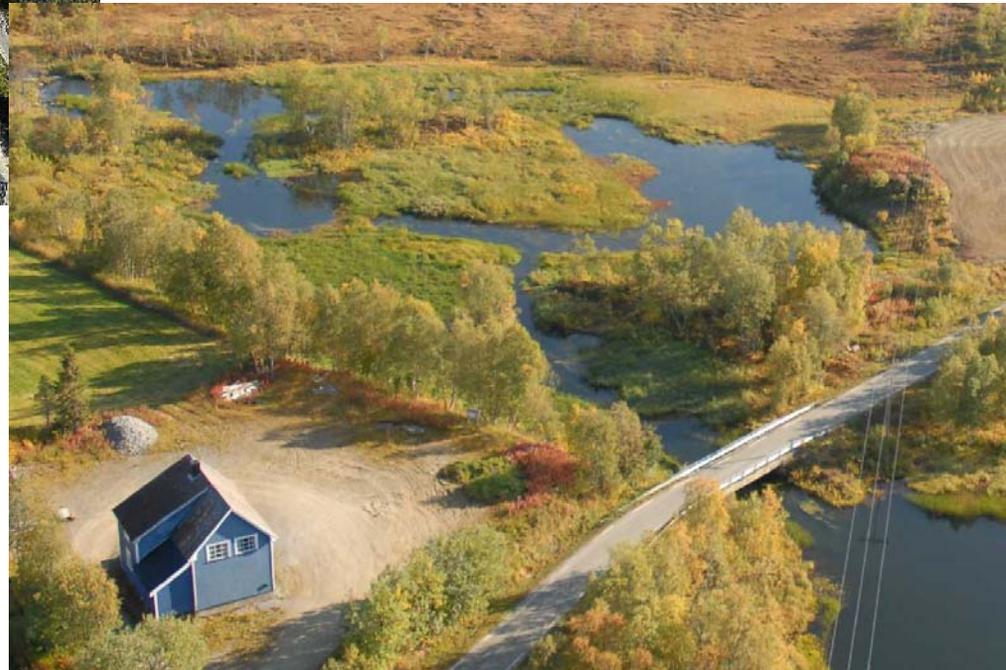
Results: Before and after

2005 → 2008
